EXECUTIVE SUMMARY

Responsible Person:	Livv Housing Group
Property Designation	General Needs
Management Extent	Partially Managed Building - Manager or Senior Staff not onsite regularly
No of Floors	11
No of Flats (if applicable)	64
Ground floor Area (m2)	25 x 32
Total Area of all Floors (m2)	
FRA Completed By	Lee Coyne
QA Carried Out By	Kevin Hudson

Property Reference	001033
Name	1X Knowsley Heights
Address 1	1X Knowsley Heights
Address 2	Huyton
Address 3	Merseyside
Address 4	High Rise
Postcode	L36 3SS
Fire Risk Assessor	Lee Coyne
Date of inspection	18/03/2025
Checked by:	Kevin Hudson
Recommended reassessment date (subject to appropriate interim management)	18/03/2026

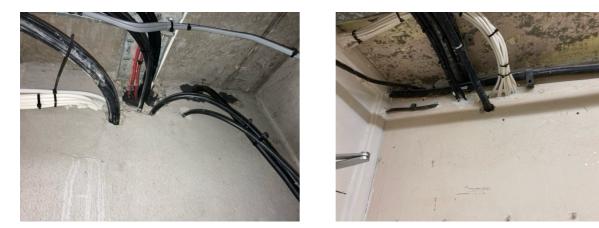
Q3 - Photo 1

Q3 Q - Limiting Fire Spread	В	Apparent unsealed service penetrations and holes present to electrical cupboard walls and boarding above door.	Appoint a competent fire works contractor and upgrade fire stopping.	1 18/03/2026
Q7 Q - Limiting Fire Spread	В	Unable to ascertain whether adequate fire stopping is provided behind areas of boxing in and where services penetrate into flats.	Investigate and upgrade fire stopping if necessary.	1 18/03/2026
